Premium Quality Oil Seals

No.: 20 (Rev. 1)

# Technical Service Bulletin

#### Subject: RING GEAR AND PINION TOOTH CONTACT PATTERNS

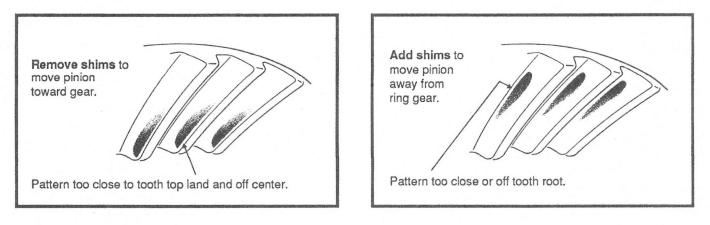
## **Incorrect Pattern - Adjust Pinion Position**

If the gear pattern shows incorrect tooth depth contact, change drive pinion position by altering the shim pack. Used gears should achieve proper contact with the same shims removed from the axle at disassembly.

**Note:** Check ring gear backlash after each shim change and adjust if necessary to maintain 0.008" to 0.018" (0.203 to 0.457 mm) backlash.

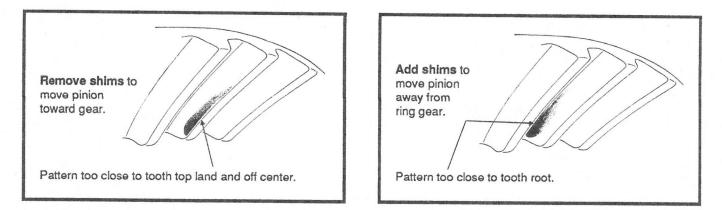
# **Incorrect Pattern - Adjust Pinion Position**

If the contact pattern shows incorrect tooth depth contact, change drive pinion position by altering the shim pack. Used gears should achieve proper contact with the same shims removed from the axle at disassembly.

**Note:** Check ring gear backlash after each shim change and adjust if necessary to maintain correct backlash (see appropriate service manual). Always recheck tooth contact pattern after making shim pack changes.
